# PROJECT PORTFOLIO

A SCRAPBOOK OF DESIGN/BUILD OVERHAULS

Building Community

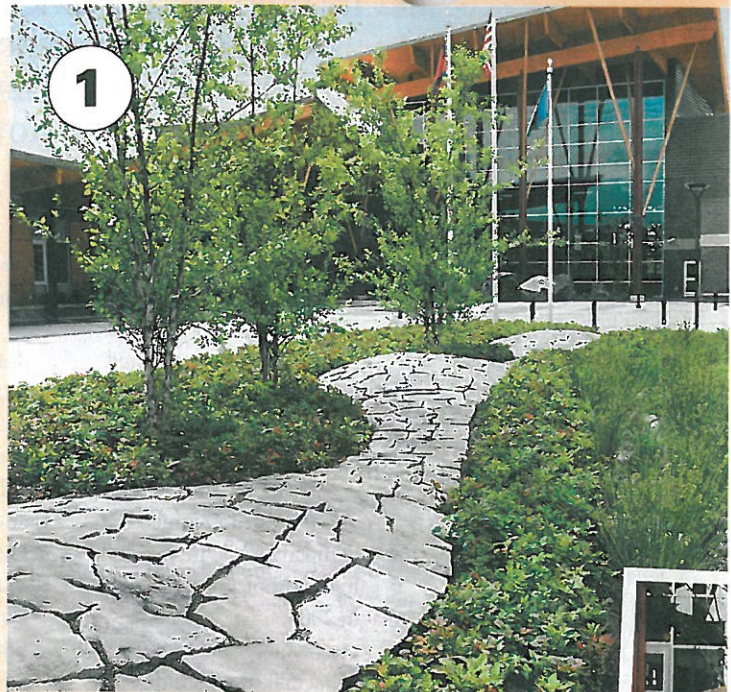
**1 | Show and shell.** What became known as the “turtle back” stone feature courses through a swale and planting bed near the front entry. “It is a unique feature of dry-set, three- to five-inch-thick stones laid in a rolling pathway that creates a fun element for children and adults to walk through the landscape,” says DeSantis.

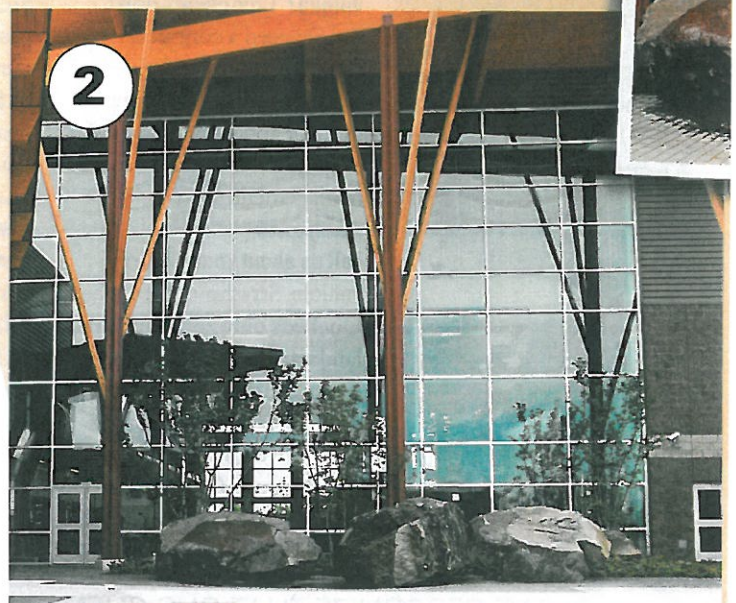
**2 | Making an entrance.** Behind the boulder water feature at the center’s entry are 30-ft.-tall specimen *Acer circinatum*, dug from a local, native forest.

The entry water feature consists of four boulders, each weighing between 25 and 40 tons. They were hand-selected by DeSantis and landscape architect Christopher Freshley from a mountainside in the Columbia River Gorge. A stone artist was then brought in to bore and cut the stones before they were loaded and trucked to the project site.

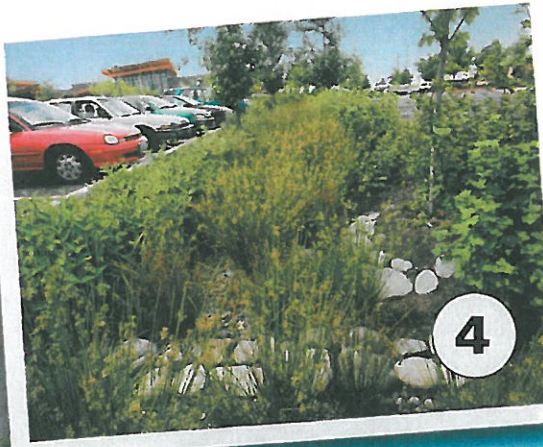
**3 | Bould over.** The two water feature boulders have 2-in. bores intercepted by 36-in. cross cuts to create a weir. All the paver work was also completed by DeSantis Landscapes.

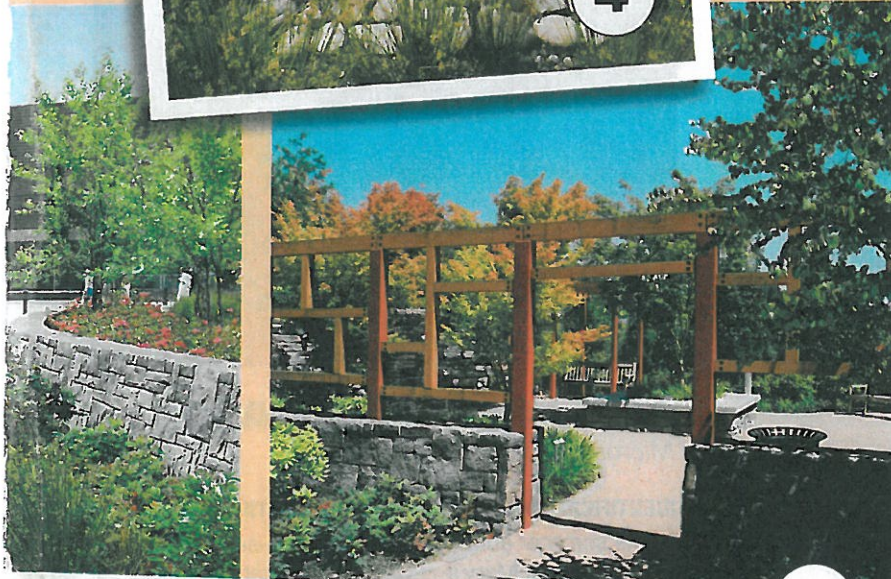
**4 | Sewer soother.** The parking lot swales were constructed using these round rock “dams” to slow stormwater as it passes through, using phytotechnology to cleanse the water before entering the sewer system. Also, curb cuts throughout the parking lot direct stormwater to the swales for filtering.

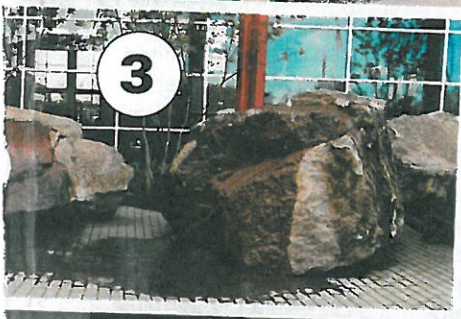
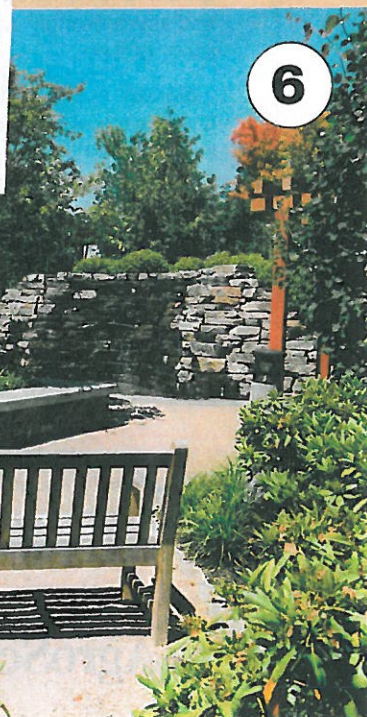
**5-6 | Tranquil space.** The prayer garden’s water feature is a mortared stack wall. The team was charged with keeping the water from running horizontally across the stones and directed into the basin. The solution? “All of the stones had to be laid at a slight canter,” DeSantis says, “while maintaining a nice horizontal stack line.”
